UN Capital Master Plan
Asbestos Abatement in the Library Building
May 2009

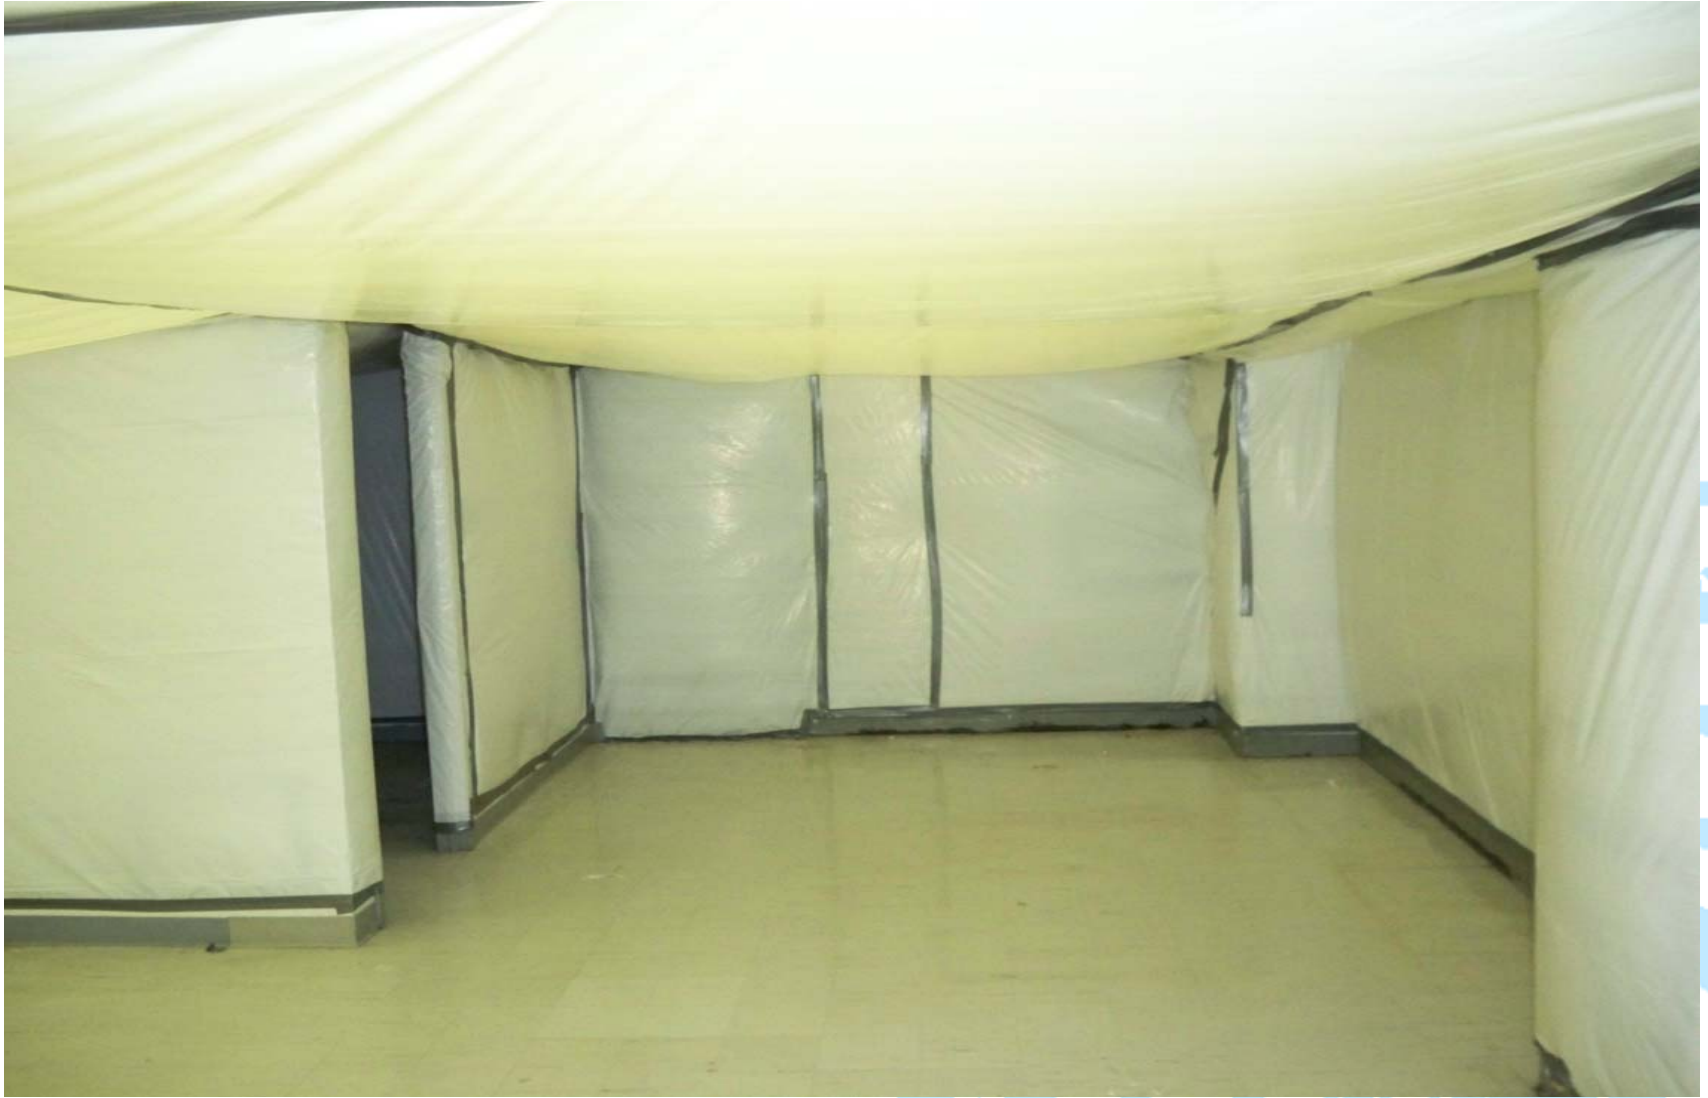
Abatement work area. Negative air machine creating underpressure by pumping filtered air out through a HEPA filter. Exits to waste decontamination and worker decontamination units are seen in the back.

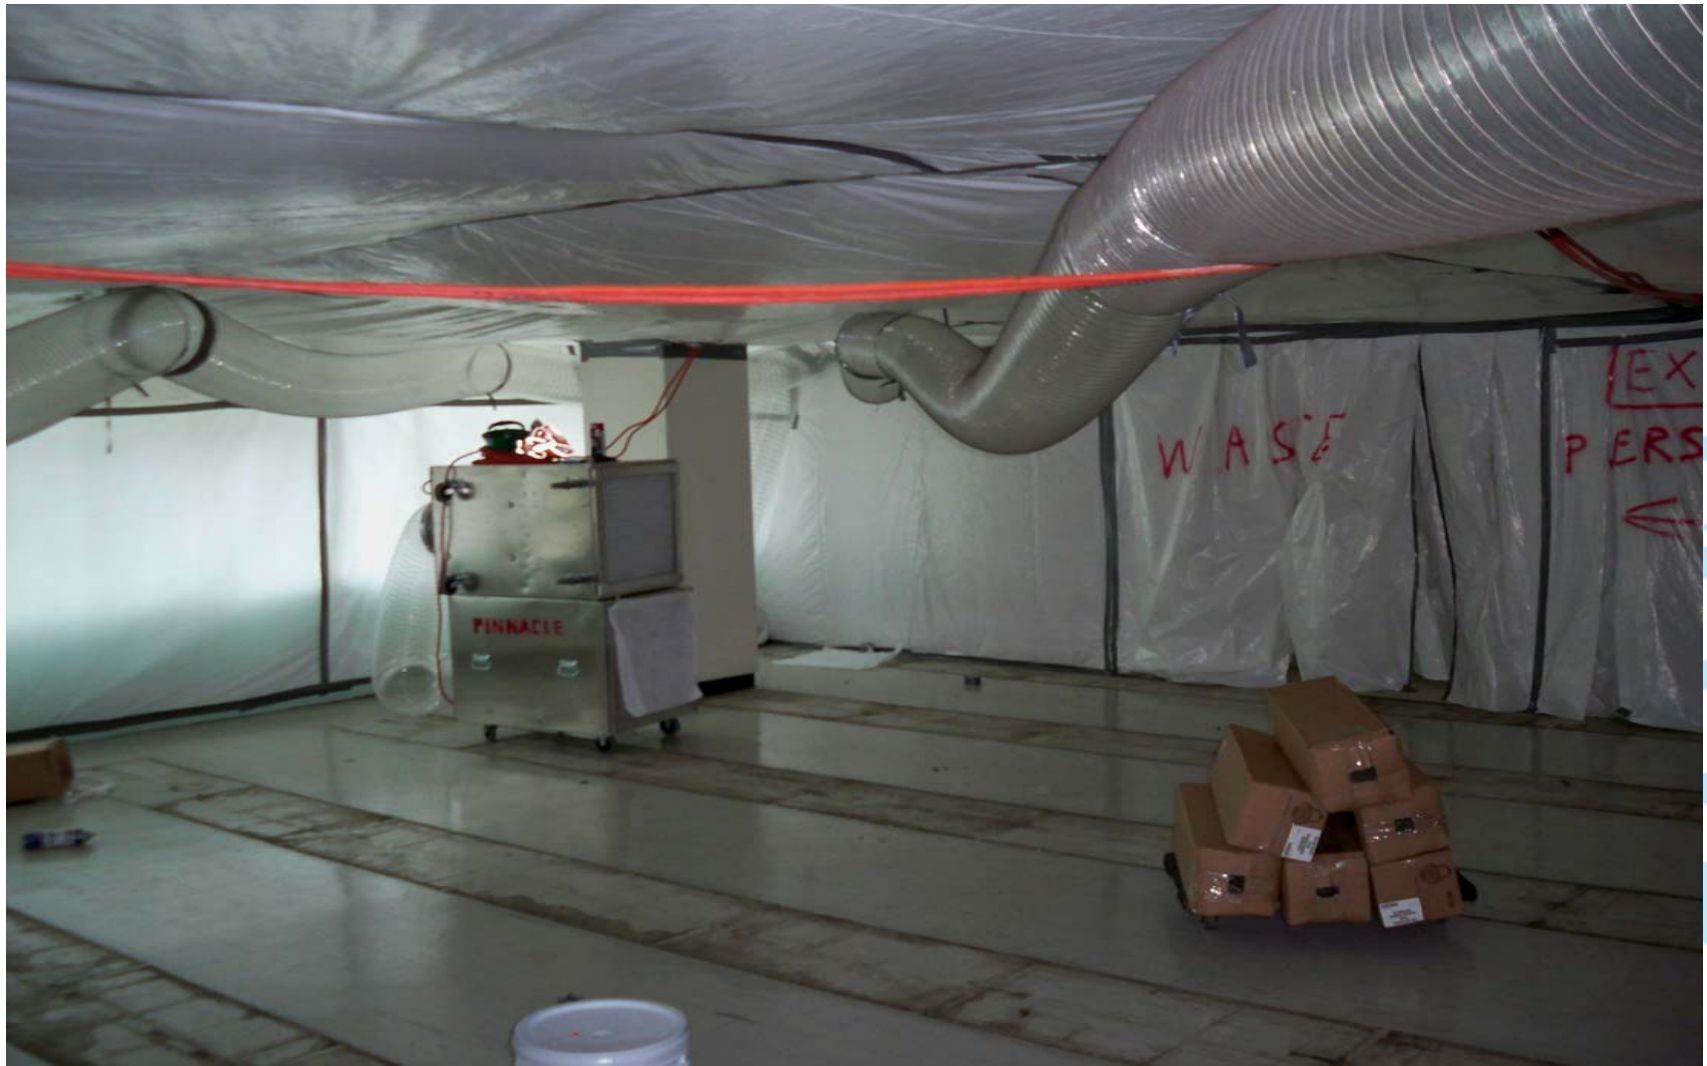
To prevent asbestos fibers from becoming airborne, amended water is sprayed over the asbestos-containing material before and during the abatement
